Flat Plate Problems

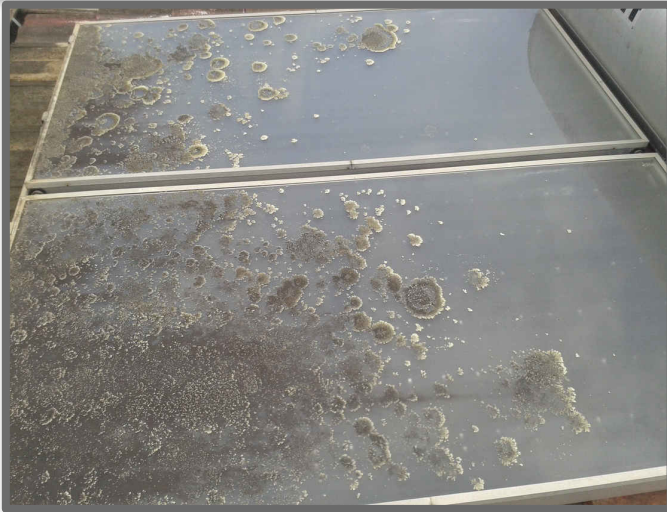
Moss Growth

Due to the surface being hot from heat bleed thru the glass surface, moss will grow in humid locations causing permanent damage to the glass and dramatically reducing performance.

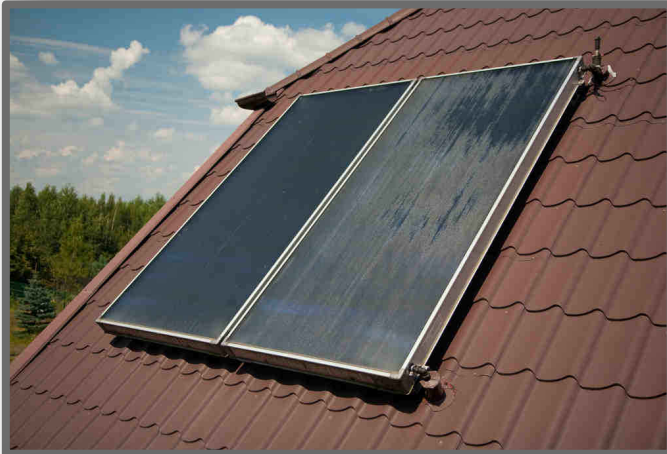
Internal Condensation

Significant condensation will build up inside the panels especially in humid locations. This occurs for much the same reason your car window fogs up when it is cold and warmer moist air is in the car. Significant performance is lost due to the blocking of light from the sun.

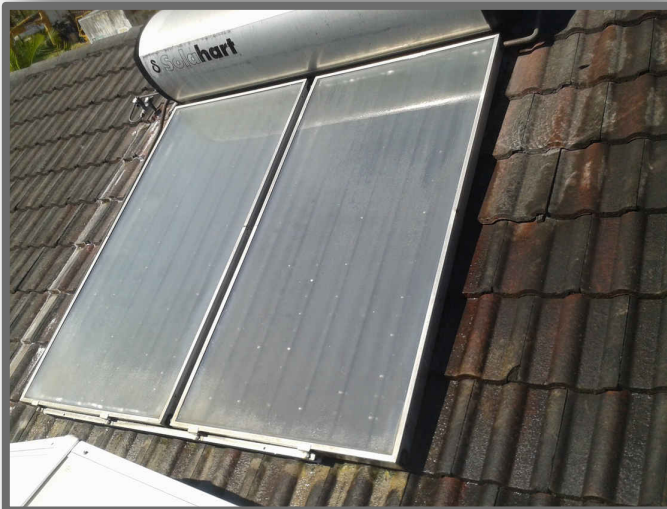
Weight & Water Leaks

Thermosyphon systems with the tank on the roof can weigh as much as 650kgs on the roof causing the roof to deform. Flat plate systems run the water thru the panels increasing the possibilities for leaks in multiple locations.
